# Combined Survey, Risk Assessment and Management Procedure for ACM's

**Property:** Unit 9, Wood Street, Poulton-le-Fylde.

**Date of Inspection:** January 18, 2017

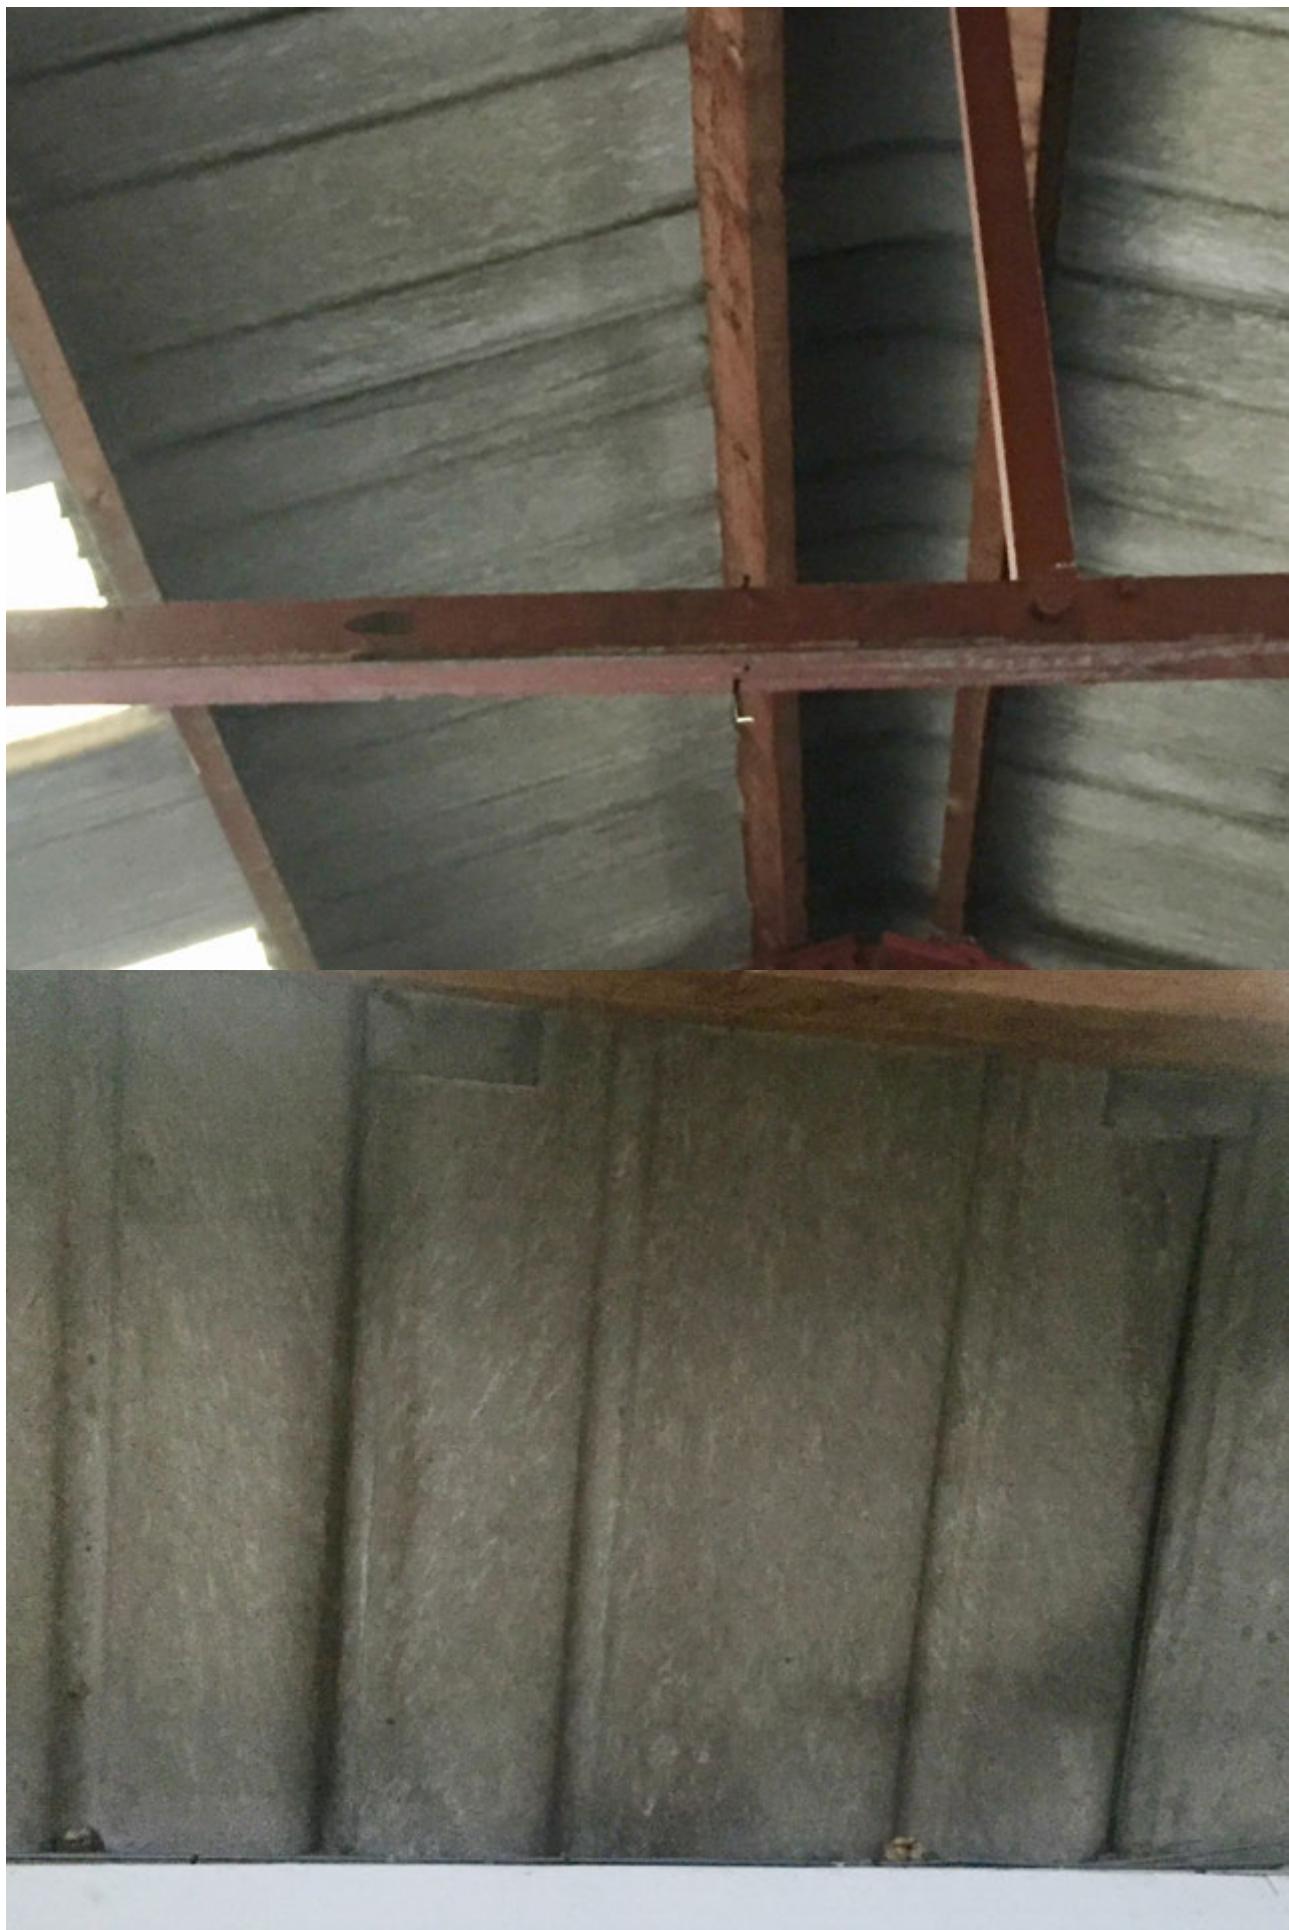
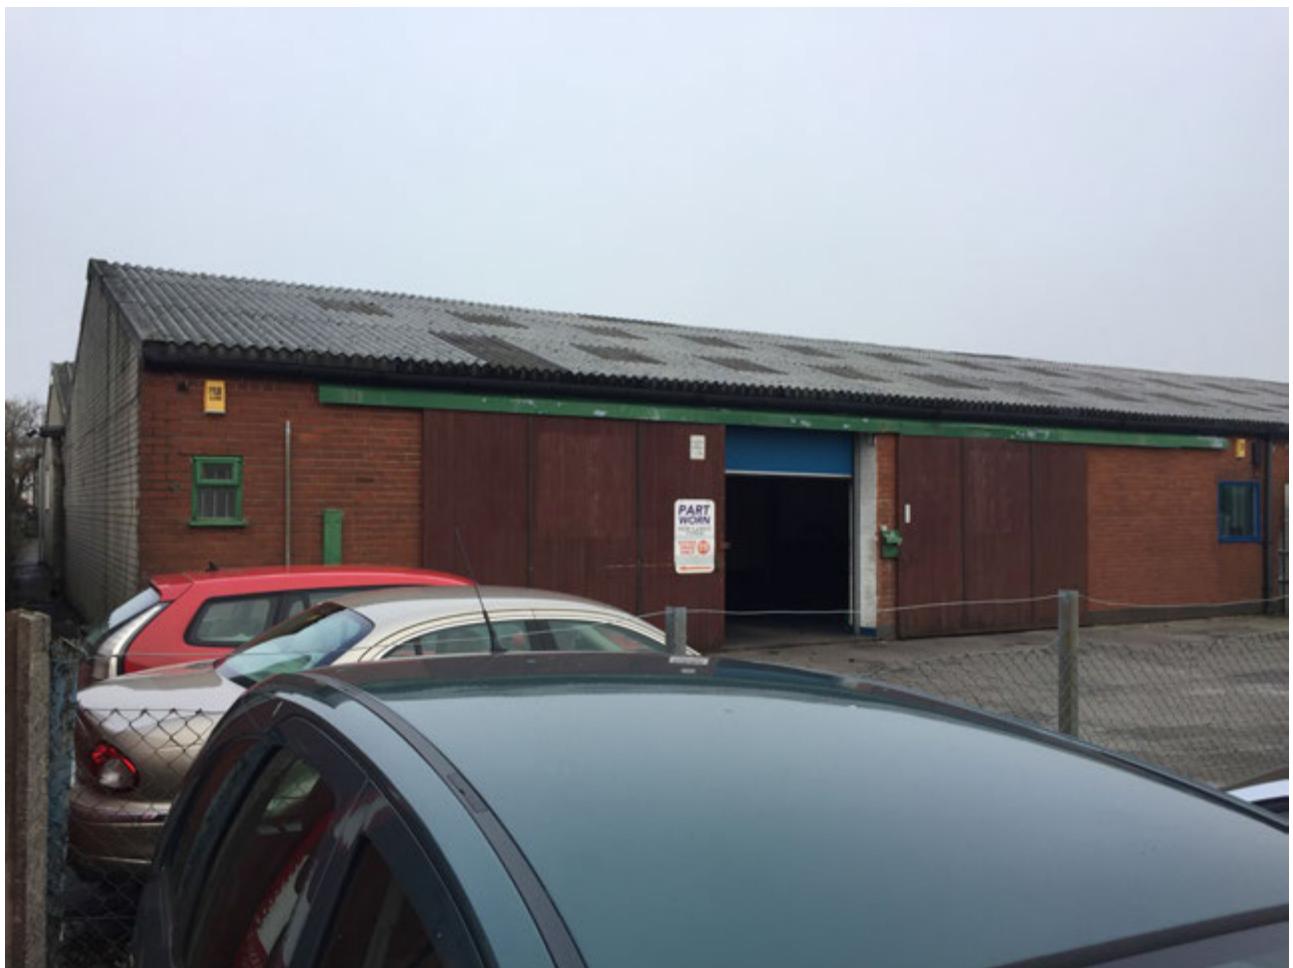
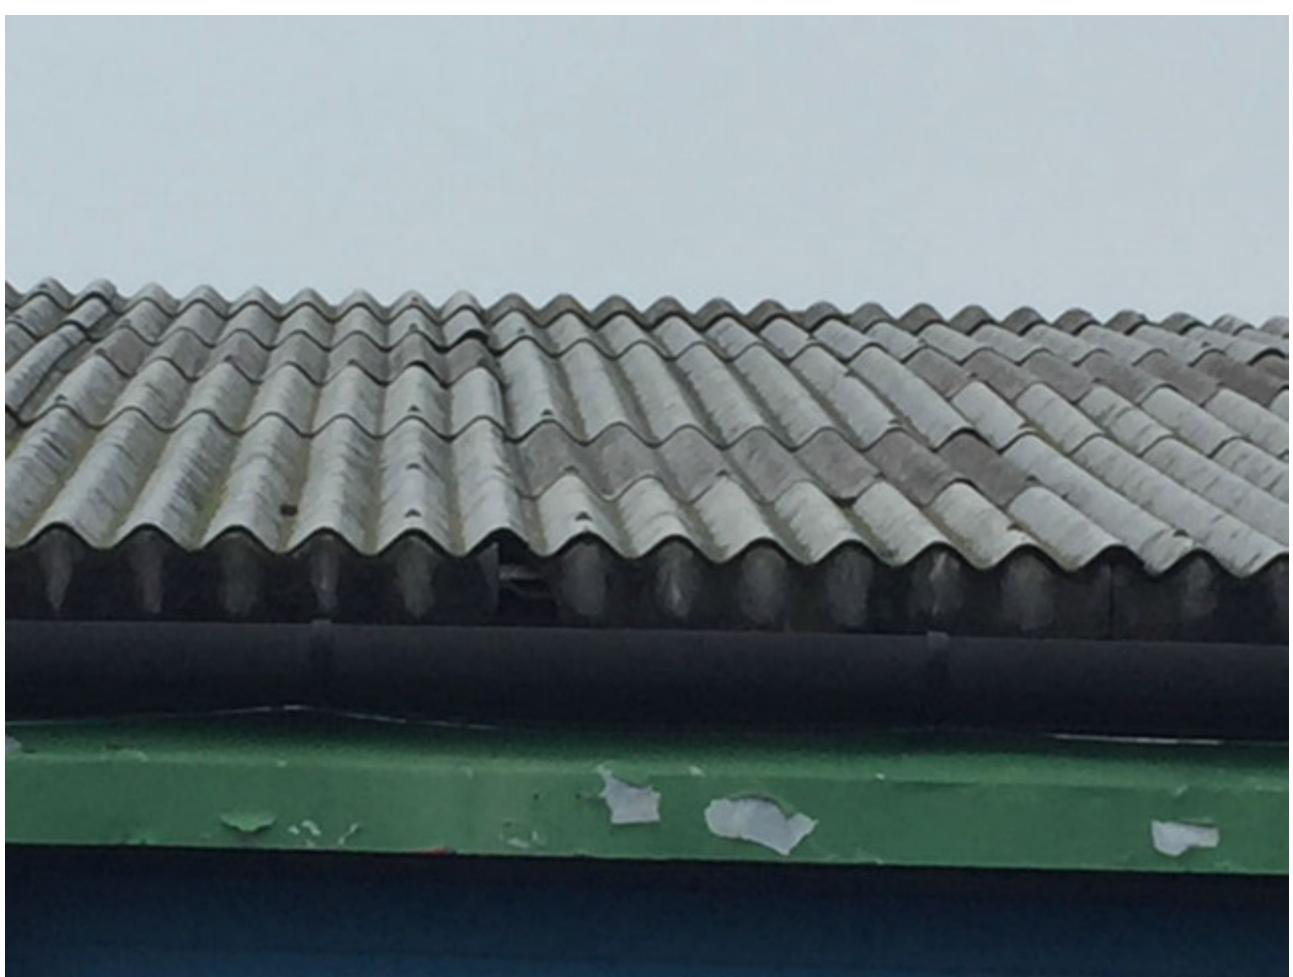
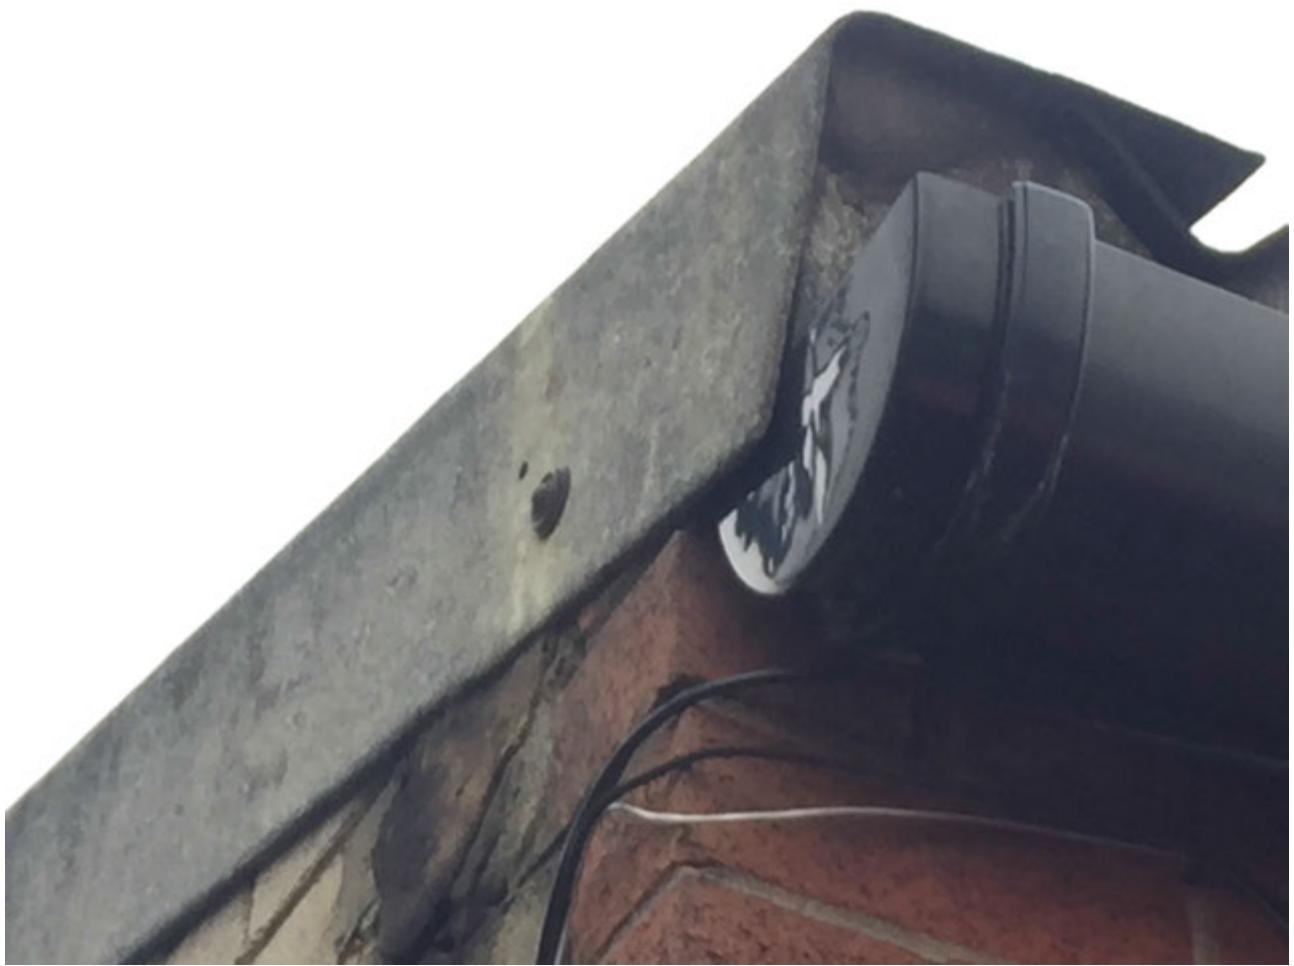
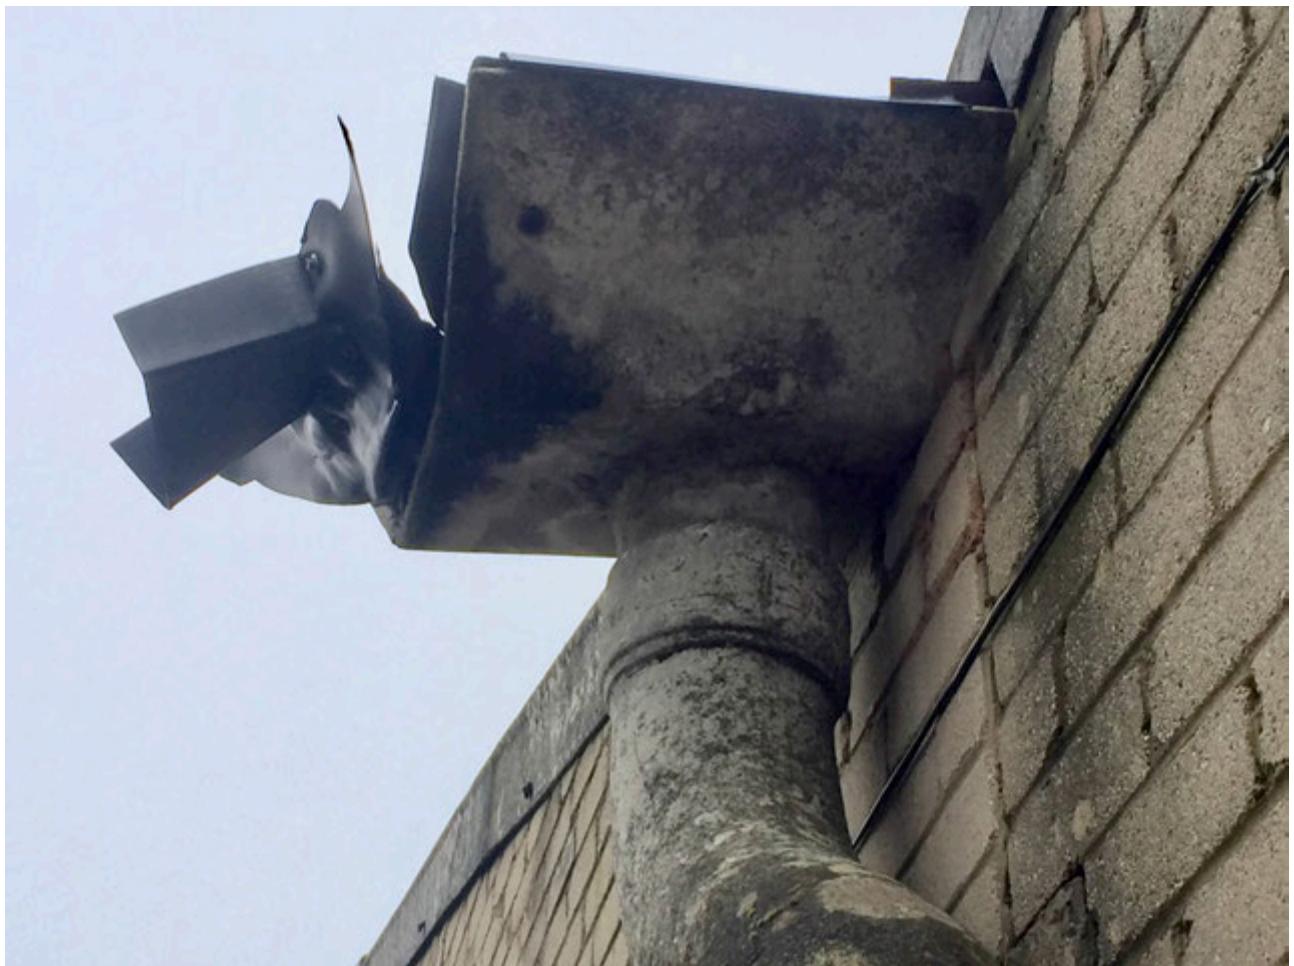
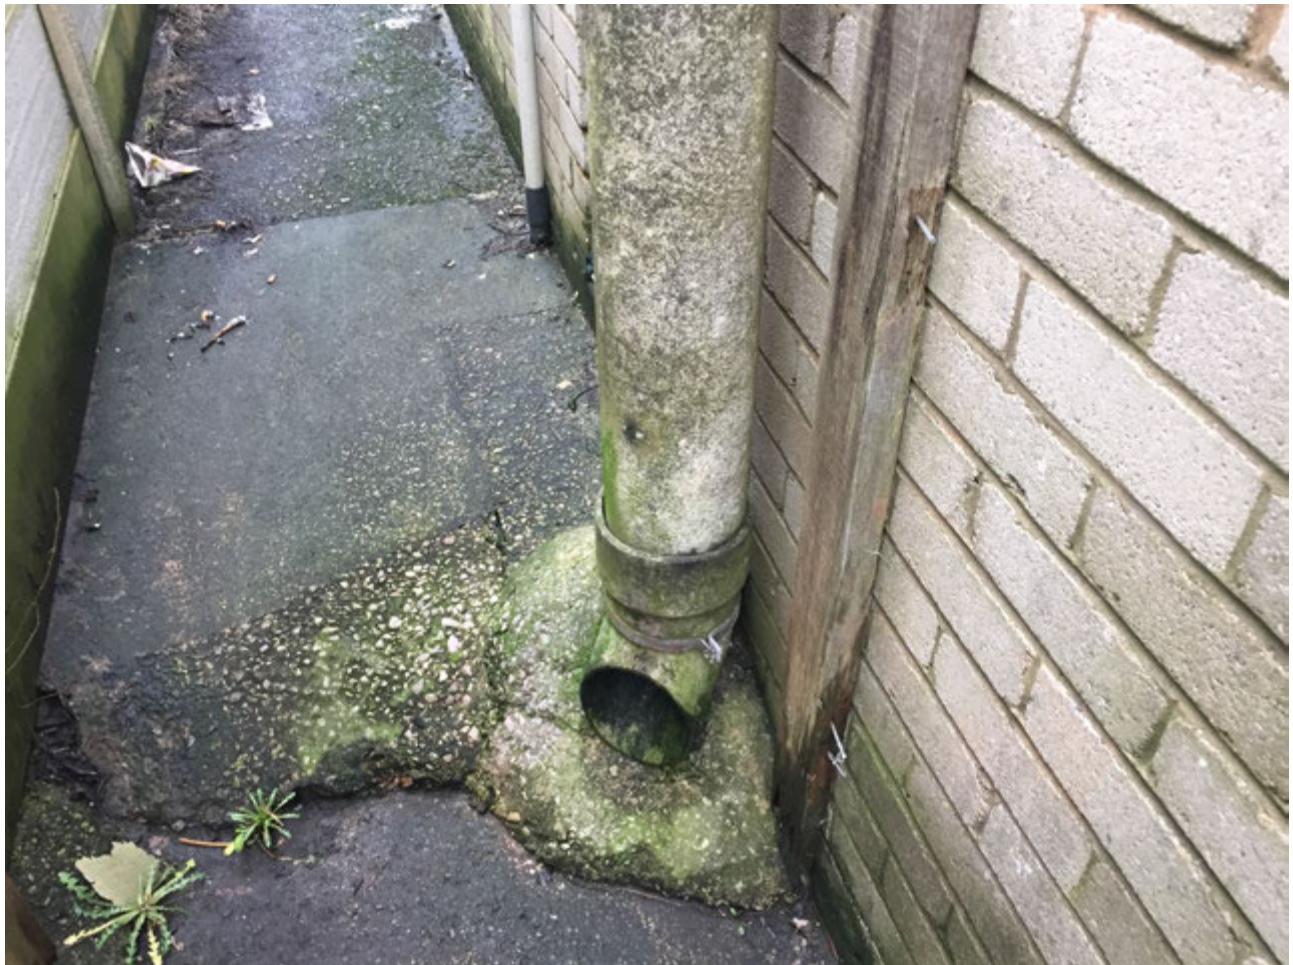
1. Roof lining sheets
2. Outer roof sheets
3. Barge boards
4. Rear Valley Gutter
5. Rainwater Downspout
