Combined Survey, Risk Assessment and
Management Procedure for ACM's

Property: Unit C, Furness Drive, Poulton-le-Fylde.

Date of Inspection: June 6, 2016

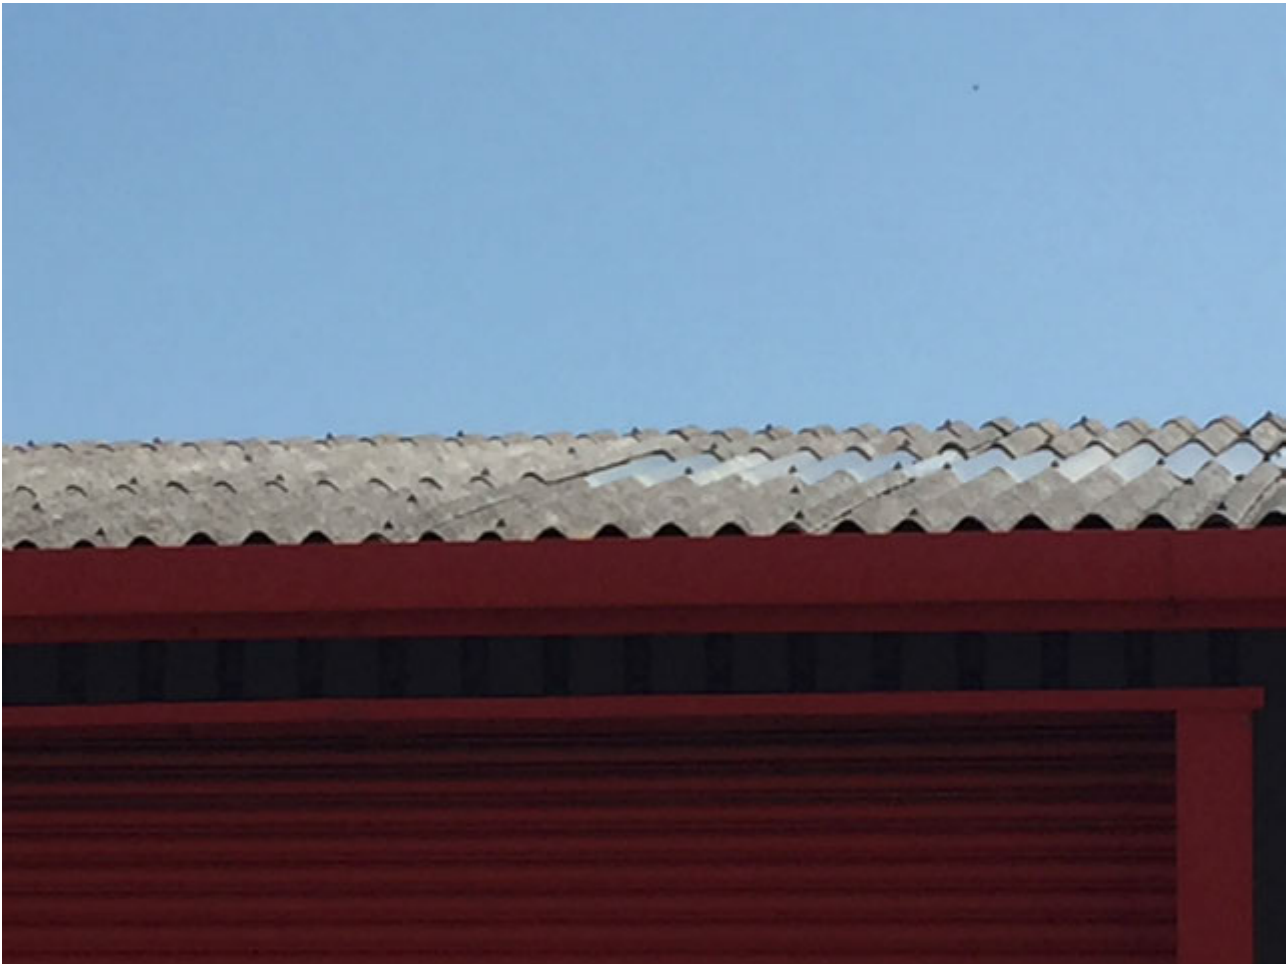
The **outer roof sheets** are located over the lining sheets (which are a polyurethane foam type material) and are visible only from outside the building, the entire roof surface is considered to be of the same product, it was noted that one sheet to the front elevation will need replacement/patching when the flue associated with the oil burning heater is removed. The common reference to this product is big six fibre cement roof sheeting. The sheeting is corrugated at six inch intervals providing strength to the sheeting.

As the property was constructed in 2001, the fibre cement board will be re-enforced with nylon strand rather than asbestos since asbestos contain roof sheets were not used by the contractor that built this property after 1997.
