MANAGEMENT ASBESTOS SURVEY REPORT

**Unit L, Cocker Avenue,
Poulton Industrial Estate,
Poulton-le Fylde. FY6 8JU.**

SURVEY REPORT WITH MATERIAL ASSESSMENT

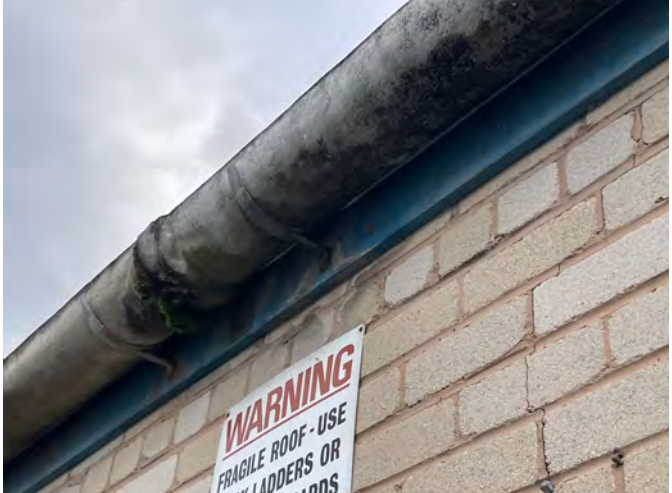
Item #	001

Location ID	L-03	
Room	External	
Description	Fibre Cement Gutter	
Surveyor	SJG	
Survey Type	Management	
Inspection Date	5 Dec 2022	
Sample #	S-001	
Lab Ref	BS164939

Type	Chrysotile	1	Location	Outdoors
Material	Fibre Cement	1	Accessibility	Unlikely to be Disturbed
Condition	Good Condition	0	Amount	≈ 9 m
Surface Treatment	Fibre Cement	1	Assessment Type	Laboratory
Material Assessment Score		3

Action	Manage	
Priority	3	
Notifiable	No	
Licensed	No	
Additional Comments		
Recommendations	<p>The asbestos cement is in a good condition and can remain in-situ if required. A management plan needs to be put in place to monitor the cement on a regular basis for any signs of deterioration or damage. Should any damage occur, then repair or removal by suitably trained persons under controlled conditions should be considered.</p>

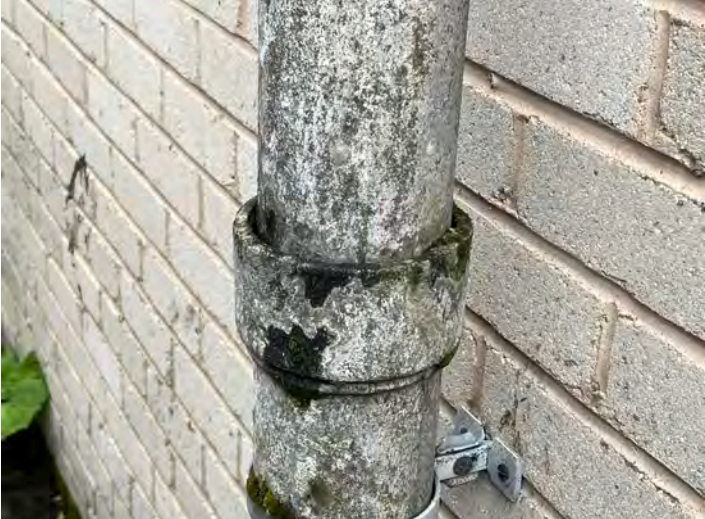
Item #	002

Location ID	L-03	
Room	External	
Description	Fibre Cement Down-spout	
Surveyor	SJG	
Survey Type	Management	
Inspection Date	5 Dec 2022	
Sample #	S-002	
Lab Ref	BS164940

Type	Chrysotile	1	Location	Outdoors
Material	Fibre Cement	1	Accessibility	Unlikely to be Disturbed
Condition	Good Condition	0	Amount	≈ 3 m
Surface Treatment	Fibre Cement	1	Assessment Type	Laboratory
Material Assessment Score		3

Action	Manage		
Priority	3		
Notifiable	No		
Licensed	No		
Additional Comments			
Recommendations	<p>The asbestos cement is in a good condition and can remain in-situ if required. A management plan needs to be put in place to monitor the cement on a regular basis for any signs of deterioration or damage. Should any damage occur, then repair or removal by suitably trained persons under controlled conditions should be considered.</p>

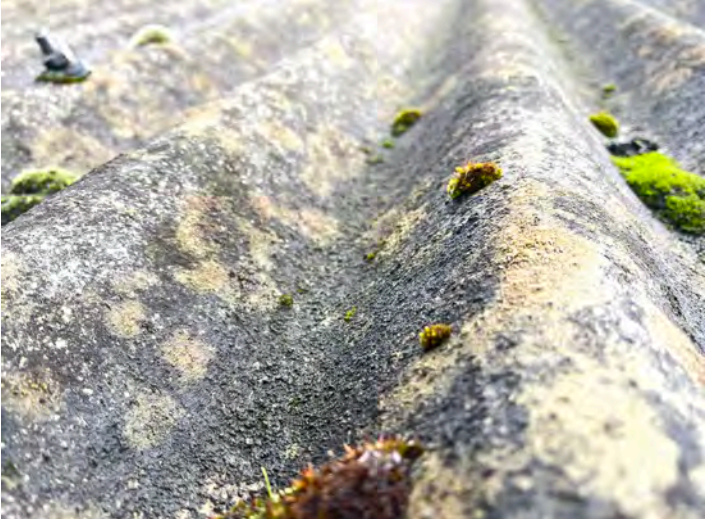
Item #	003

Location ID	L-03	
Room	External	
Description	Fibre Cement Roof Sheeting	
Surveyor	SJG	
Survey Type	Management	
Inspection Date	5 Dec 2022	
Sample #	S-003	
Lab Ref	BS164941

Type	Chrysotile	1	Location	Outdoors
Material	Fibre Cement	1	Accessibility	Unlikely to be Disturbed
Condition	Good Condition	0	Amount	≈ 160 m ²
Surface Treatment	Fibre Cement	1	Assessment Type	Laboratory
Material Assessment Score		3

Action	Manage	
Priority	3	
Notifiable	No	
Licensed	No	
Additional Comments		
Recommendations	The asbestos cement is in a good condition and can remain in-situ if required. A management plan needs to be put in place to monitor the cement on a regular basis for any signs of deterioration or damage. Should any damage occur, then repair or removal by suitably trained persons under controlled conditions should be considered.
