# MANAGEMENT ASBESTOS SURVEY REPORT

**Unit M, Cocker Avenue,  
Poulton Industrial Estate,  
Poulton-le Fylde. FY6 8JU.**

# SURVEY REPORT WITH MATERIAL ASSESSMENT

**Date of Inspection:** December 5, 2022.

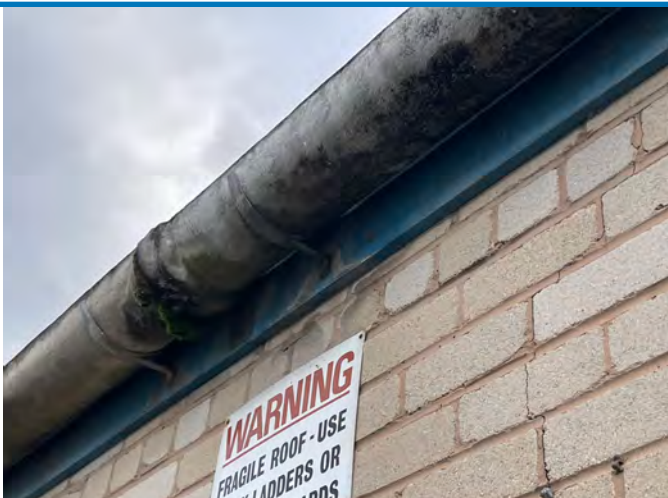
| <b>Item #</b> | 001 | |

| Item | Location | Item Description | Recommendations |
|---|---|---|---|
| 1 | L-02 External | Fibre Cement Gut-<br>tering | MANAGE (AC) - GOOD - The asbestos cement is in a good condition and can remain in-situ if required. A management plan needs to be put in place to monitor the cement on a regular basis for any signs of deterioration or damage. Should any damage occur, then repair or removal by suitably trained persons under controlled conditions should be considered. |

| <b>Condition</b> | Good Condition | 0 | <b>Amount</b> | ≈ 9 m |

| <b>Recommendations</b> | <p>The asbestos cement is in a good condition and can remain in-situ if required. A management plan needs to be put in place to monitor the cement on a regular basis for any signs of deterioration or damage. Should any damage occur, then repair or removal by suitably trained persons under controlled conditions should be considered.</p> | |

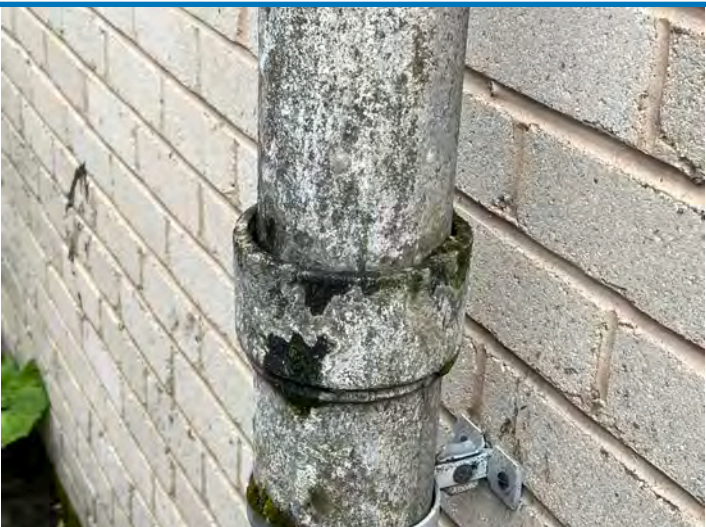
| <b>Item #</b> | 002 | |

| Item | Location | Item Description | Recommendations |
|---|---|---|---|
| 2 | L-02 External | Fibre Cement<br>Downspout | MANAGE (AC) - GOOD - The asbestos cement is in a good condition and can remain in-situ if required. A management plan needs to be put in place to monitor the cement on a regular basis for any signs of deterioration or damage. Should any damage occur, then repair or removal by suitably trained persons under controlled conditions should be considered. |

| <b>Condition</b> | Good Condition | 0 | <b>Amount</b> | ≈ 3 m |

| <b>Recommendations</b> | The asbestos cement is in a good condition and can remain in-situ if required. A management plan needs to be put in place to monitor the cement on a regular basis for any signs of deterioration or damage. Should any damage occur, then repair or removal by suitably trained persons under controlled conditions should be considered. | |

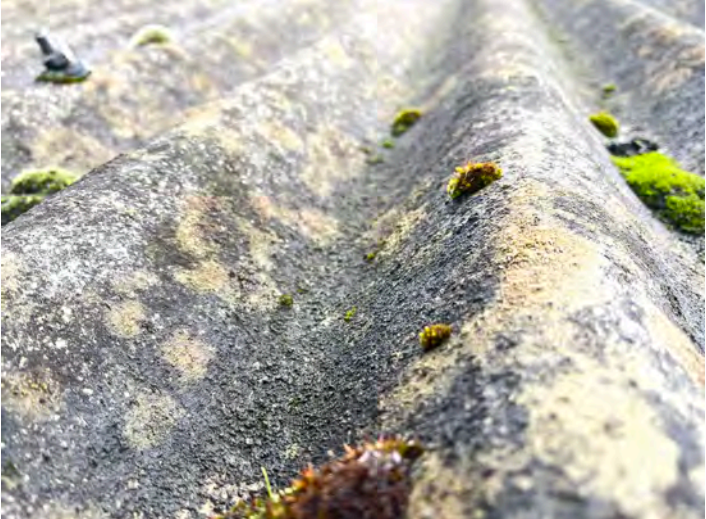
| <b>Item #</b> | 003 | |

| Item | Location | Item Description | Recommendations |
|---|---|---|---|
| 3 | L-02 External | Fibre Cement Roof<br>Sheets | MANAGE (AC) - GOOD - The asbestos cement is in a good condition and can remain in-situ if required. A management plan needs to be put in place to monitor the cement on a regular basis for any signs of deterioration or damage. Should any damage occur, then repair or removal by suitably trained persons under controlled conditions should be considered. |

| <b>Condition</b> | Good Condition | 0 | <b>Amount</b> | ≈ 160 m <sup>2</sup> |

| <b>Recommendations</b> | <p>The asbestos cement is in a good condition and can remain in-situ if required. A management plan needs to be put in place to monitor the cement on a regular basis for any signs of deterioration or damage. Should any damage occur, then repair or removal by suitably trained persons under controlled conditions should be considered.</p> | |
