Combined Survey, Risk Assessment and  
Management Procedure for ACM's

**Property:** Unit O, Cocker Avenue, Poulton-le-Fylde.

**Date of Inspection:** August 25, 2016

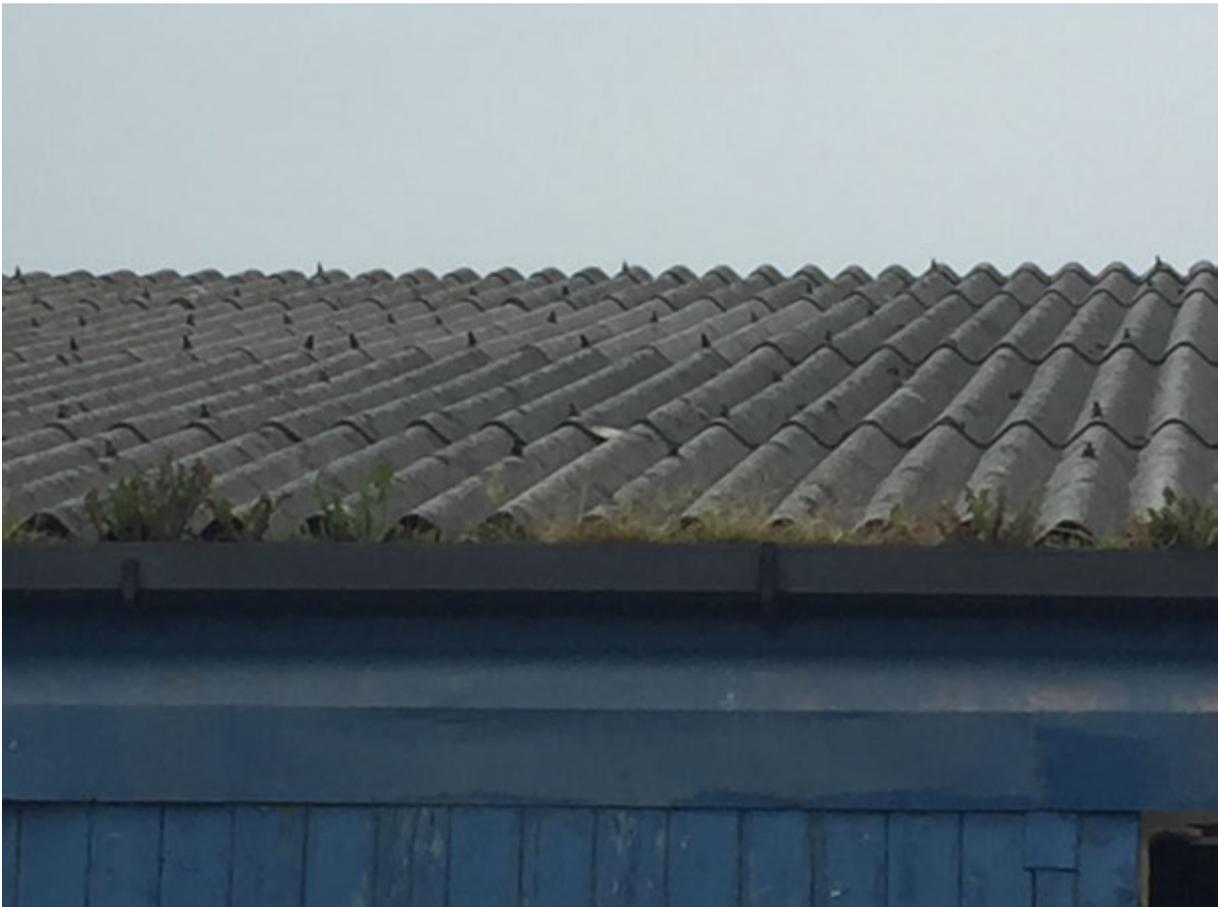
The **outer roof sheets** are located over the plasterboard and airliner insulation boards and are visible only from outside the building, the entire roof surface is considered to be of the same product, although there is evidence that at least one sheet has been replaced at some point, there is no information about when this occurred. The location of any replacement represented a significant hazard of fall for the purpose of a closer visual inspection, the surveyor chose not to inspect these sheets and to regard them in the same manner as the remainder of the outer roof sheets. The common reference to this product is big six fibre cement roof sheeting. The sheeting is corrugated at six inch intervals providing strength to the sheeting.

Being outdoors the sheets are considered to be in good condition despite their age, although the presence of limited moss and lichens suggested a slight deterioration of the surface. The sheeting has suffered discolouration over time, the absence of any cleaner or lighter coloured areas reinforce the opinion of there being no substantial deterioration.

The edges of the sheeting where exposed, show a small amount of rounding associated with weathering, but this process is clearly limited as the edges display the same extent of discolouration as the surfaces and nothing more than expected given the age of the sheeting.

White fibres are clearly visible and for the same reasons as those given for the roof lining sheets the material was assumed to contain chrysolite.

The material assessment score of the sheeting is 3, and the overall potential to release fibres is categorised as 'very low'.

1. Position and condition of external sheets

Although the extent of occurrence of the material within the property is substantial, the day to day inaccessibility of location in connection with the difficulties involved in any removal and the hazards involved in doing so mean that the recommended course of action is one of continued management.

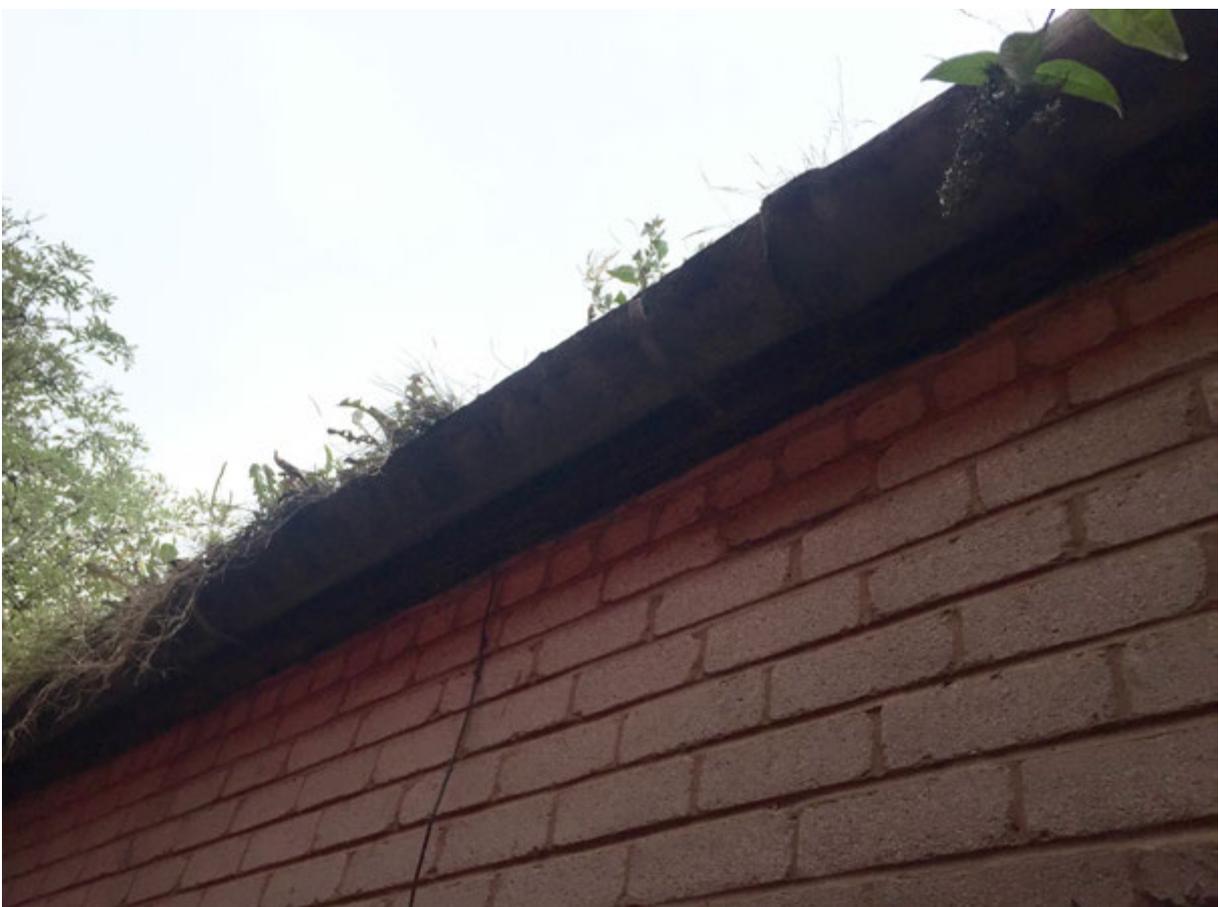
The **gutters** are located to the eaves of the property on the rear elevation only, they are fixed beneath the lower edge of the outer roofing sheets to collect water from them. The property is a terrace property and no downspout is present on the subject property. The common reference to this product is fibre cement guttering . The guttering to the front elevation has been replaced with modern uPVC.

Generally the gutters are considered to be in a fair condition, although the presence of limited moss and lichens to the outside of the gutter suggested a slight deterioration of the surface. The external surface of the guttering has suffered discolouration over time, the absence of any cleaner or lighter coloured areas reinforce the opinion of there being no substantial deterioration.

The internal surface of the gutters could not be examined at the time of inspection as they were full of accumulated debris and growth. Being at the rear of the premises the possibility of damage from impact from high sided vehicles is negligent and the gutters show no signs of such damage.

The material assessment score of the sheeting is 4, and the overall potential to release fibres is categorised as 'low'.

2. Position and condition of rear guttering

Although the extent of occurrence of the material within the property is moderate, the day to day inaccessibility of location in connection with the difficulties involved in any short term removal and the hazards involved in doing so mean that the recommended course of action is one of continued management..
