# MANAGEMENT ASBESTOS SURVEY REPORT

**Unit Y2, Beacon Road,  
Poulton Industrial Estate,  
Poulton-le Fylde. FY6 8JE.**

# SURVEY REPORT WITH MATERIAL ASSESSMENT

**Date of Inspection:** February 24, 2023.

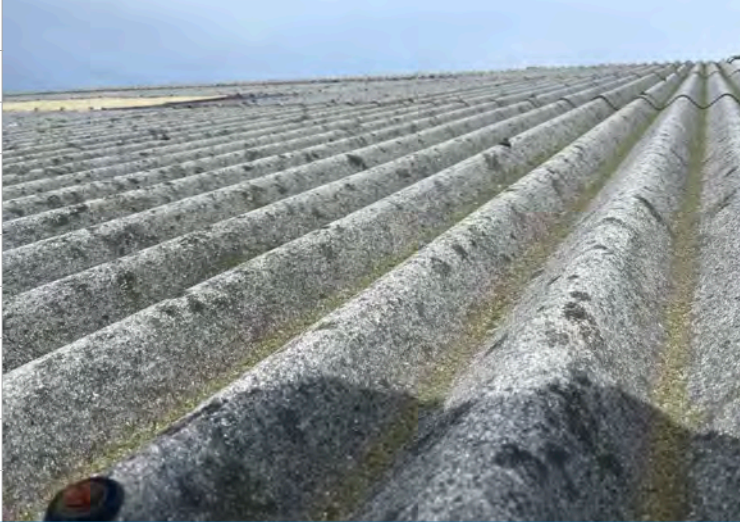
<b>Item #</b>	001

<b>Location ID</b>	L-01	
<b>Room</b>	External	
<b>Description</b>	Fibre Cement Roof Sheeting	
<b>Surveyor</b>	SJG	
<b>Survey Type</b>	Management	
<b>Inspection Date</b>	24 Feb 2023	
<b>Sample #</b>	Y2-001	
<b>Lab Ref</b>	N/a

<b>Type</b>	Chrysotile	1	<b>Location</b>	Outdoors
<b>Material</b>	Fibre Cement	1	<b>Accessibility</b>	Unlikely to be Disturbed
<b>Condition</b>	Good Condition	0	<b>Amount</b>	≈ 350 m <sup>2</sup>
<b>Surface Treatment</b>	Fibre Cement	1	<b>Assessment Type</b>	Laboratory
<b>Material Assessment Score</b>		3

<b>Action</b>	Manage	
<b>Priority</b>	3	
<b>Notifiable</b>	No	
<b>Licensed</b>	No	
<b>Additional Comments</b>	N/a	
<b>Recommendations</b>	The asbestos cement is in good condition and can remain in situ if required. A management plan needs to be put in place to monitor the cement on a regular basis for any signs of deterioration or damage. Should any damage occur, then repair, or removal by suitably trained persons under controlled conditions should be considered.

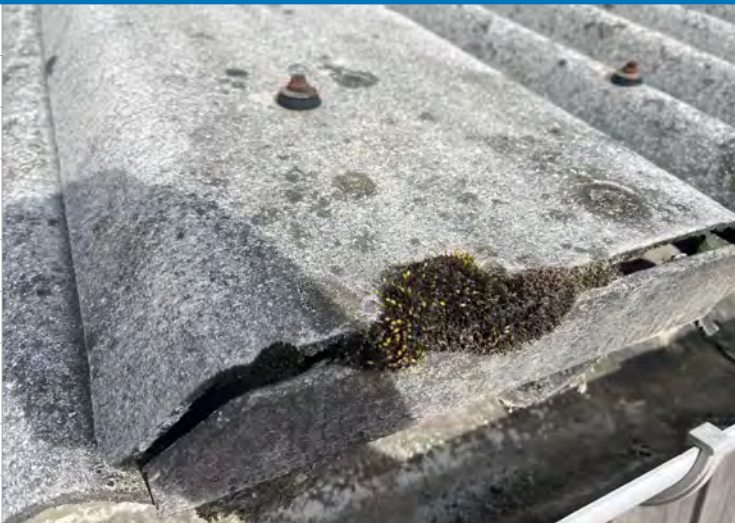
<b>Item #</b>	002

<b>Location ID</b>	L-02	
<b>Room</b>	External	
<b>Description</b>	Fibre Cement Roof Sheet Capping	
<b>Surveyor</b>	SJG	
<b>Survey Type</b>	Management	
<b>Inspection Date</b>	24 Feb 2023	
<b>Sample #</b>	Y2/Y3-002 (02)	
<b>Lab Ref</b>	N/a

<b>Type</b>	N/a	0	<b>Location</b>	Outdoors
<b>Material</b>	N/a	0	<b>Accessibility</b>	Unlikely to be Disturbed
<b>Condition</b>	N/a	0	<b>Amount</b>	≈ 6 m <sup>2</sup>
<b>Surface Treatment</b>	N/a	0	<b>Assessment Type</b>	Laboratory
<b>Material Assessment Score</b>		0

<b>Action</b>	N/a	
<b>Priority</b>	N/a	
<b>Notifiable</b>	No	
<b>Licensed</b>	No	
<b>Additional Comments</b>	No asbestos was identified within the sample analysed.	
<b>Recommendations</b>	N/a
