MANAGEMENT ASBESTOS SURVEY REPORT

**Unit Z3, Beacon Road,
Poulton Business Park,
Poulton-le Fylde. FY6 8JE.**

SURVEY REPORT WITH MATERIAL ASSESSMENT

Date of Report: May 5, 2024.

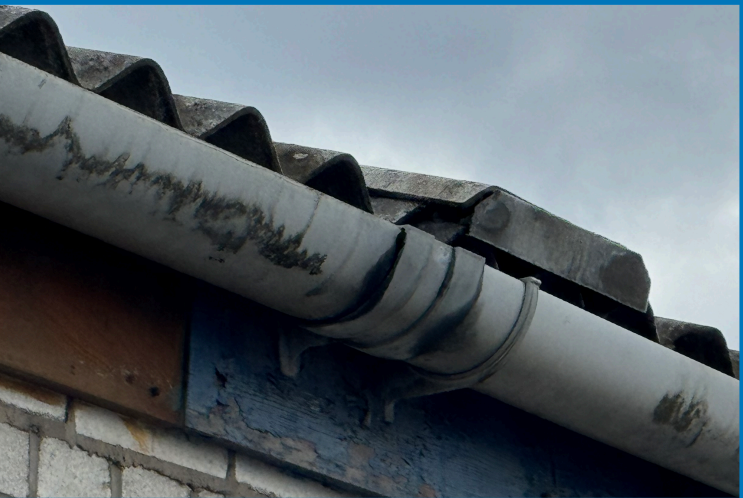
Item #	001

Location ID	L-02	
Room	External	
Description	Fibre Cement Board	
Surveyor	SJG	
Survey Type	Management	
Inspection Date	30 Apr 2024	
Sample #	S-001	
Lab Ref	N/a

Type	N/a	0	Location	N/a
Material	N/a	0	Accessibility	N/a
Condition	N/a	0	Amount	N/a
Surface Treatment	N/a	0	Assessment Type	Laboratory
Material Assessment Score		0

Action	N/a	
Priority	0	
Notifiable	No	
Licensed	No	
Additional Comments	No asbestos was identified within the sample analysed.	
Recommendations	N/a

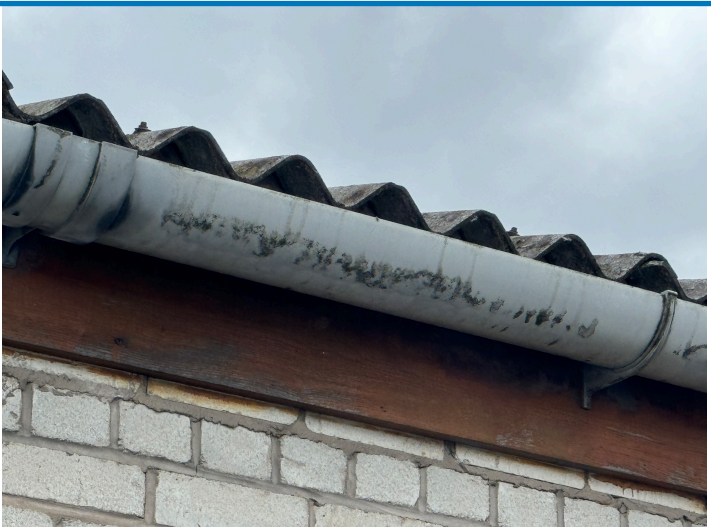
Item #	002

Location ID	L-01	
Room	External	
Description	Fibre Cement Roof Sheeting	
Surveyor	SJG	
Survey Type	Management	
Inspection Date	30 Apr 2024	
Sample #	S-002	
Lab Ref	N/a

Type	Chrysotile	1	Location	Outdoors
Material	Fibre Cement	1	Accessibility	Unlikely to be Disturbed
Condition	Good Condition	0	Amount	≈ 380 m ²
Surface Treatment	Fibre Cement	1	Assessment Type	Laboratory
Material Assessment Score		3

Item	Location	Item Description	Recommendations
1	L-02 External	Fibre Cement Roof Sheets	MANAGE - The asbestos cement is in good condition and can remain in situ if required. A management plan needs to be put in place to monitor the cement on a regular basis for any signs of deterioration or damage. Should any damage occur, then repair, or removal by suitably trained persons under controlled conditions should be considered.

Action	Manage	
Priority	3	
Notifiable	No	
Licensed	No	
Additional Comments	N/a	
Recommendations	<p>The asbestos cement is in good condition and can remain in situ if required. A management plan needs to be put in place to monitor the cement on a regular basis for any signs of deterioration or damage. Should any damage occur, then repair, or removal by suitably trained persons under controlled conditions should be considered.</p>

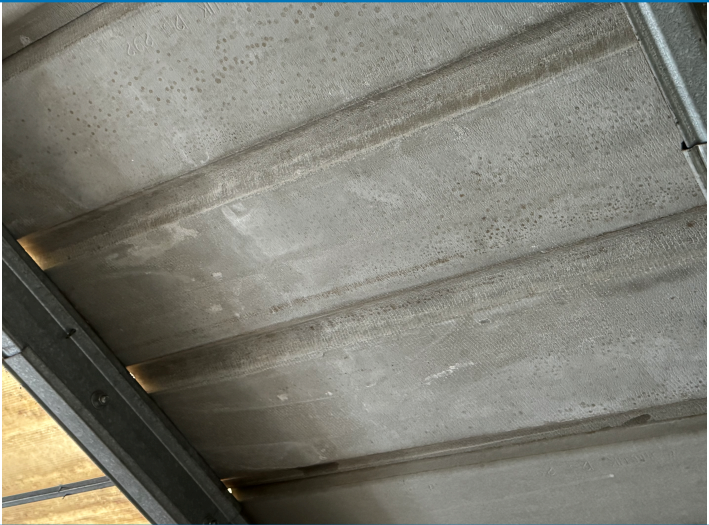
Item #	003

Location ID	L-02	
Room	Warehouse	
Description	Fibre Cement Roof Sheeting	
Surveyor	SJG	
Survey Type	Management	
Inspection Date	30 Apr 2024	
Sample #	S-003	
Lab Ref	N/a

Type	N/a	0	Location	N/a
Material	N/a	0	Accessibility	N/a
Condition	N/a	0	Amount	N/a
Surface Treatment	N/a	0	Assessment Type	Laboratory
Material Assessment Score		0

Action	N/a	
Priority	0	
Notifiable	No	
Licensed	No	
Additional Comments	No asbestos was identified within the sample analysed.	
Recommendations	The asbestos cement is in good condition and can remain in situ if required. A management plan needs to be put in place to monitor the cement on a regular basis for any signs of deterioration or damage. Should any damage occur, then repair, or removal by suitably trained persons under controlled conditions should be considered.
