Combined Survey, Risk Assessment and
Management Procedure for ACM's

Property: Unit 19, Cocker Avenue, Poulton-le-Fylde.

Date of Inspection: January 18, 2017

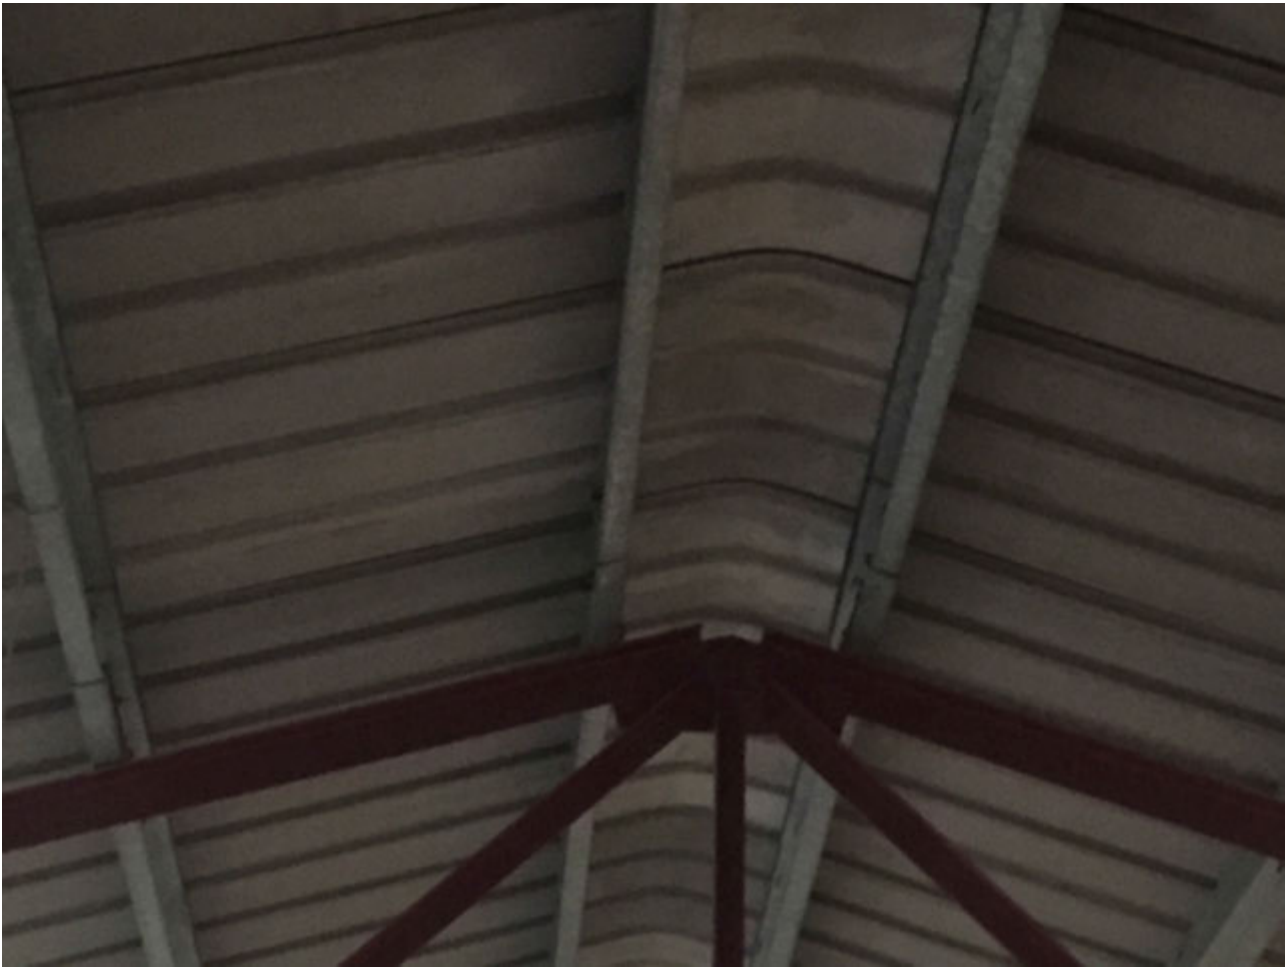
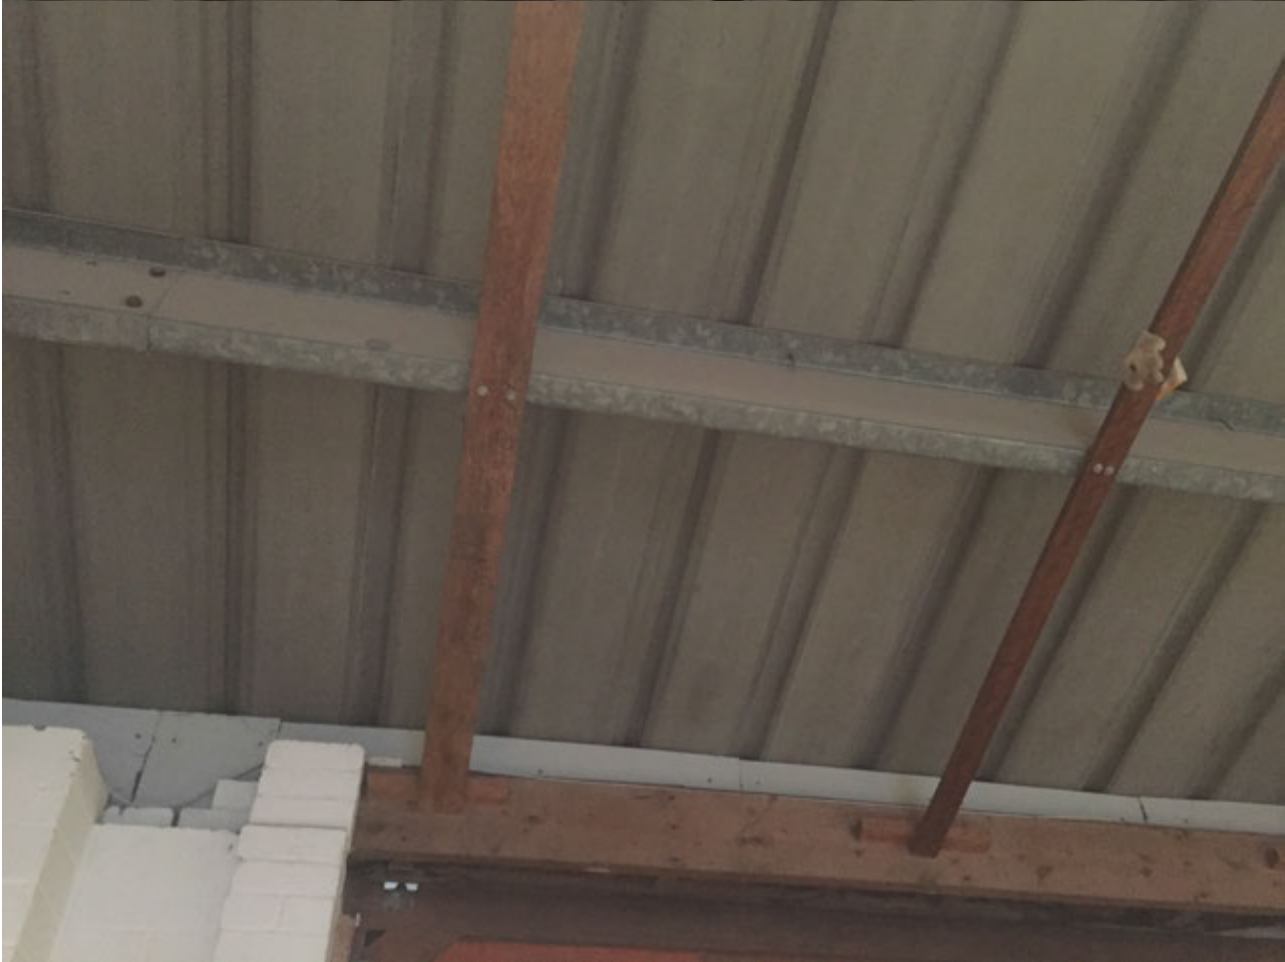
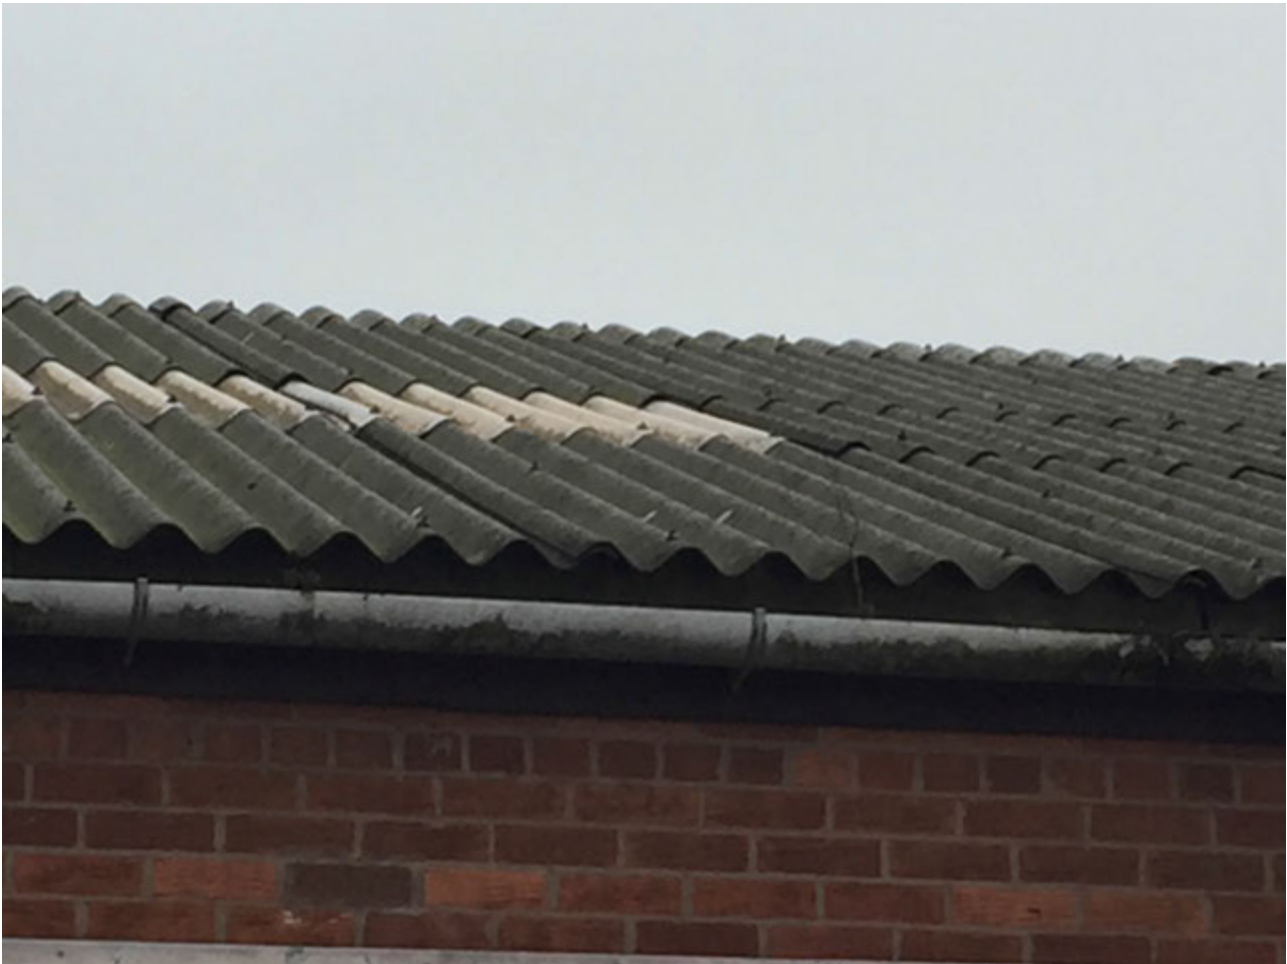
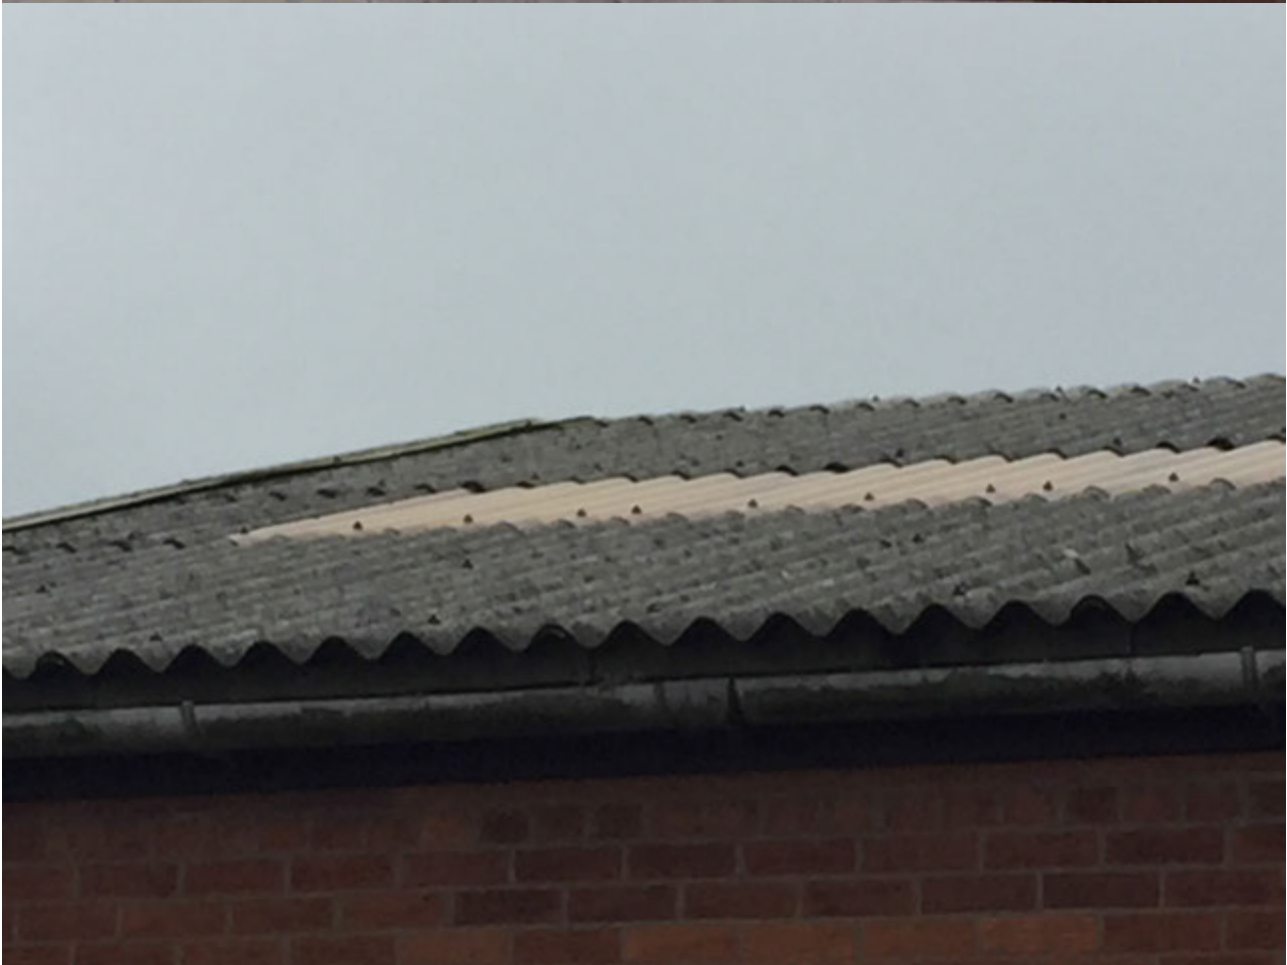
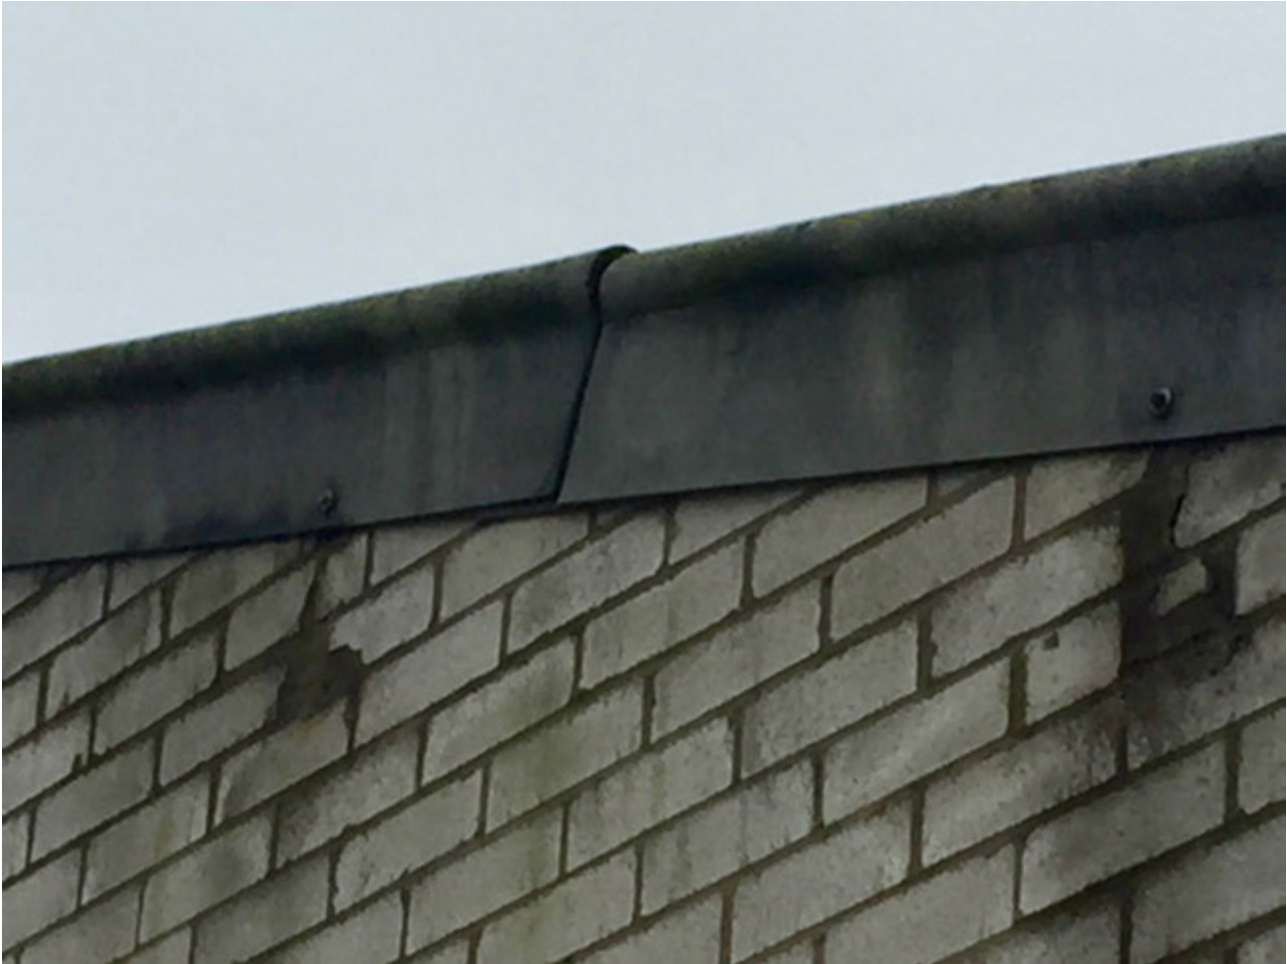
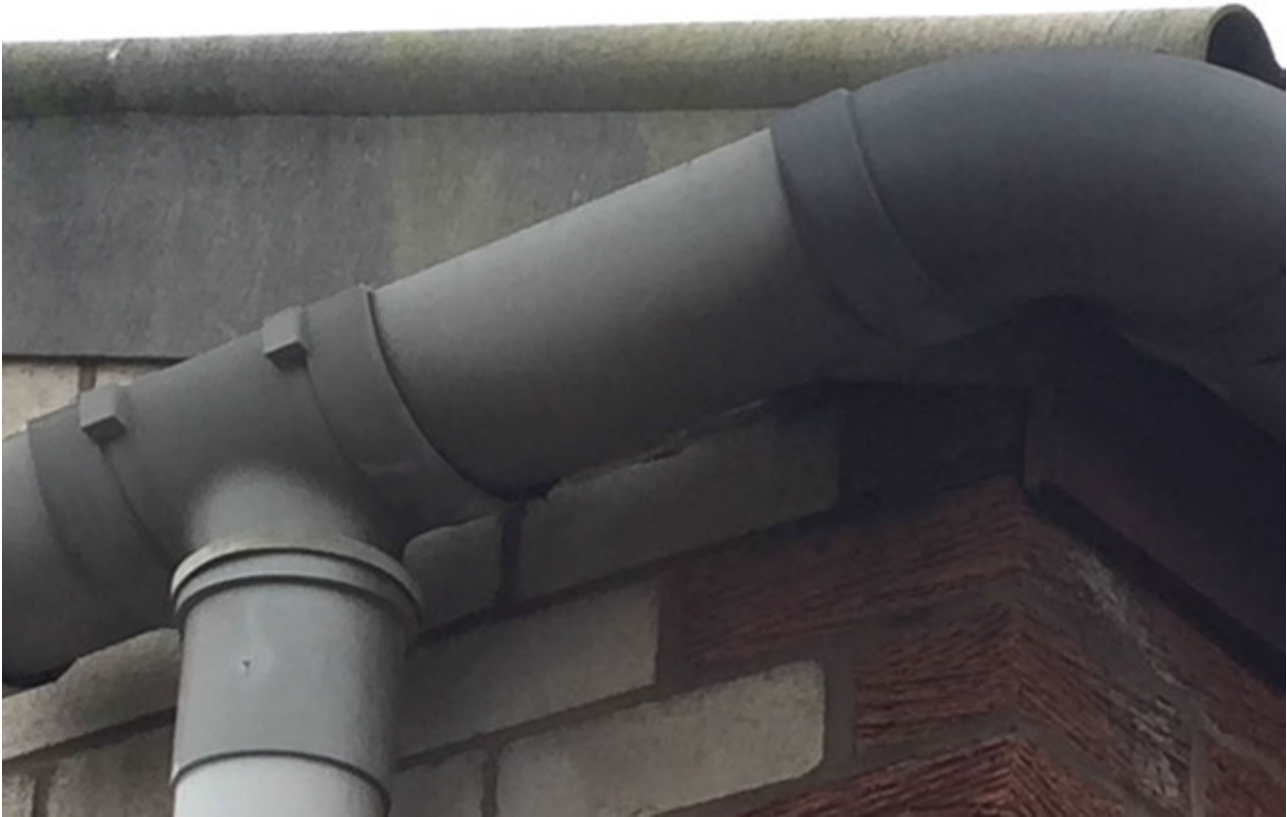
The **roof lining sheets** are located under the outer sheets and are visible from within the building, the entire underside of the roof surface is considered to be of the same product as there is no evidence of replacement sheeting. The common reference to this product is fibre cement lining. The sheeting is mainly flat with 4 equal corrugations providing strength to the sheeting.

Being indoors the lining sheets are considered to be in good condition despite their age, there is no signs of deterioration. In this condition it is difficult to make a close examination of the content, a small pair of pliers were used to nibble the edge of the sheeting to expose a small area for visual examination with a magnifying lens.

The **outer roof sheets** are located over the lining sheets and are visible only from outside the building, the entire roof surface is considered to be of the same product, there is no evidence that any sheets have been replaced although at the time of the inspection it was noted that one sheet to the front elevation is damaged and in need of replacement. The common reference to this product is big

Being outdoors the sheets are considered to be in good condition despite their age. The sheeting has suffered little discolouration over time, the absence of any cleaner or lighter coloured areas reinforce the opinion of there being no substantial deterioration.

The **barge boards** are located over the edge of the outer roofing sheets where it meets with the gable wall of the property and are visible only from outside the building. The common reference to this product is fibre cement barge board or edging trim . The section is 'L' shaped and is fixed both from above through the roof and to the vertical side surface into the wall, the purpose is to stop water ingress between the roof and the top of the wall.

Although the extent of occurrence of the material within the property is substantial, the day to day inaccessibility of location in connection with the difficulties involved in any removal and the hazards involved in doing so mean that the recommended course of action is one of continued management.

Although the extent of occurrence of the material within the property is moderate, the day to day inaccessibility of location in connection with the difficulties involved in any removal and the hazards involved in doing so mean that the recommended course of action is one of continued management.
